MGB GT gear change issues – photos at the end of this article

The Problem

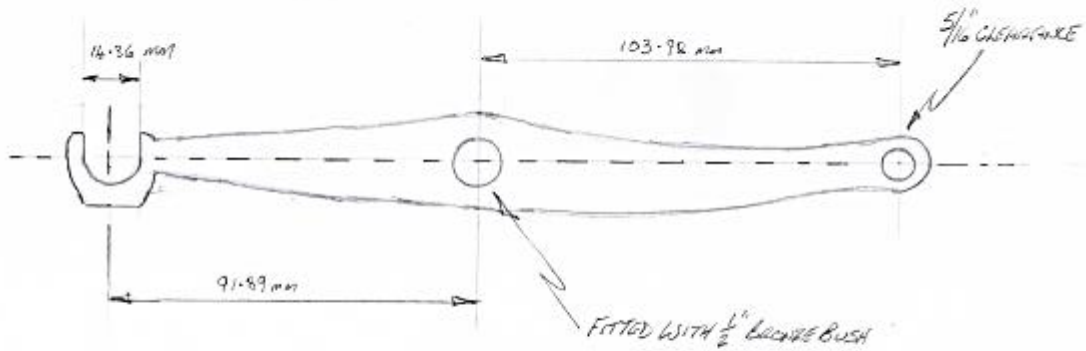
MGB CLUTCH FORK

3. The clutch fork ratio is equivalent to 0.88, and therefore a slave movement of 9.72mm would equate to a thrust bearing displacement of 8.5mm
4. The necessary operational figure of 8mm (quoted by a reliable source) for full release of the clutch equates well with the maximum calculated theoretical displacement of 8.5mm particularly when it is noted that some initial movement of the master cylinder piston is required to pass the expansion hole.

mm	INCH	PROBABLE DESIGN
14.76	0.581	9/16"
91.89	3.617	3 5/8"
103.72	4.082	4 1/8"

⇒ Inner SLAVE ROD MOUNTING ± 0.02 ON THRUST BRUSH
 9.72 MAX SLAVE ± 0.5mm OR 0.037"

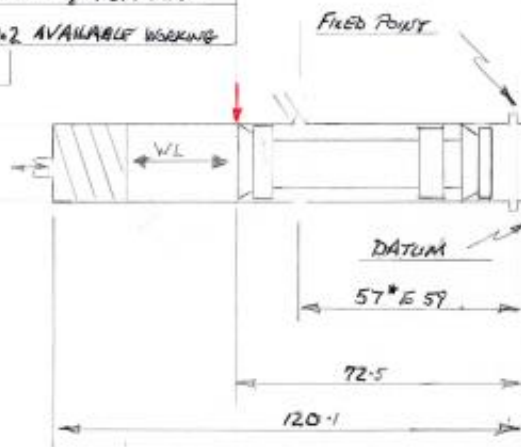
MGB CLUTCH MASTER CYLINDER

NOTES: THE CHAMBER DEPTH WAS MEASURED AT 120.1 SUBTRACTING COIL BOUND VALUE AND SPOOL ASSEMBLED LENGTH AND THE DISTANCE TO CIRCLIP GROOVE, AND SPRING PLATFORM (18.3 + 7.0 + 2.7 + 0.9) FROM 120.1 LEAVES 28.2 AVAILABLE WORKING LENGTH

DO NOT SCALE AS DRAWN THE CHAMBER IS SHORT BY 2MM ±

SPRING FREE LENGTH 74.4
COIL BOUND 18.3
AS MEASURED ON THE BENCH AVAILABLE WORKING LENGTH 27.5
ASSEMBLED LENGTH OF SPOOL WITH ROD + CIRCLIP TO SPRING PLATFORM TO 0
EXPANSION HOLE TO DATUM SHOWN IN RED 72.5

BEST APPROXIMATE DISTANCE TO EXPANSION HOLE CORRESPONDING TO EDGE OF LIP SEAL TO WITHIN 0.5mm (BY EYE) GAUGED FROM SPRING BASE

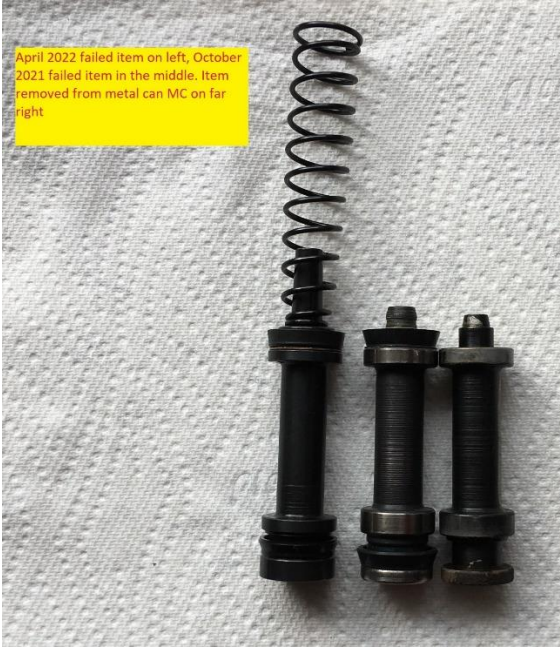
April 2022 failed item on left, October 2021 failed item in the middle, Item removed from metal can MC on far right

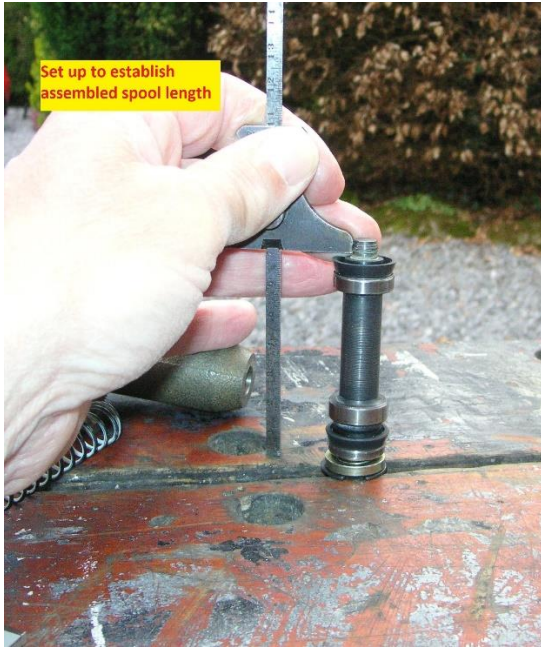
Set up to establish assembled spool length

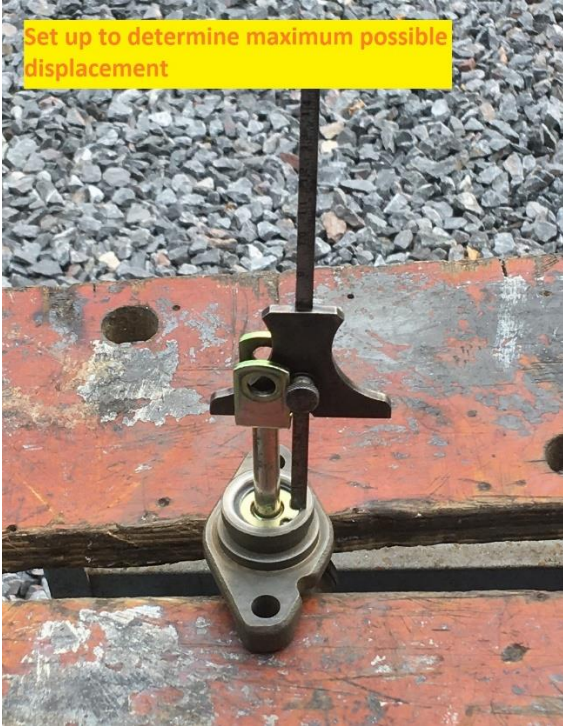
Set up to determine maximum possible displacement

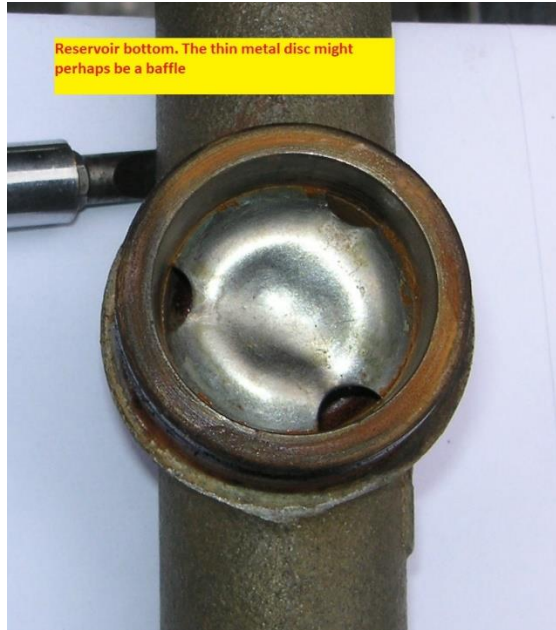
Reservoir bottom. The thin metal disc might perhaps be a baffle
