# SUBFRAME replacement

## MGF & TF

**PART ONE:** In the first of a two-part series, **Rob Hawkins** watches as Retro Sports Cars and Vehicle Handling Solutions replace the front subframe on an MG TF.

# MGF & TF FRONT SUBFRAME REPLACEMENT

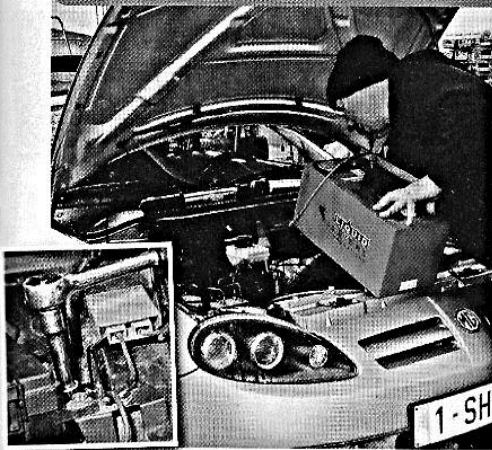
**1** ◀ On the MGF, the Hydragas suspension system needs to be degassed using a suitable pump (it's pumped up to around 400psi). There are two Schrader valves for the Hydragas, located under the bonnet. The upper mounting nuts for the front dampers also need to be undone from under the bonnet.

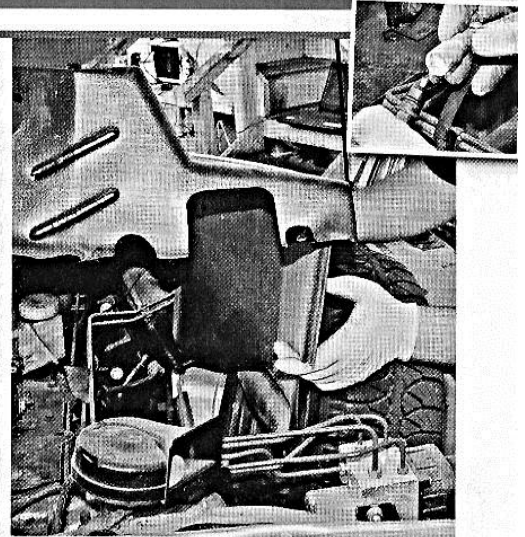
**2** ▶ After draining the coolant by releasing one of the coolant pipes underneath, Chris continued to work underneath the bonnet, removing the plastic liner by undoing a series of 10mm nuts, and detaching the ABS wiring to allow the wires to the front wheel speed sensors to be fed through the wheelarches.

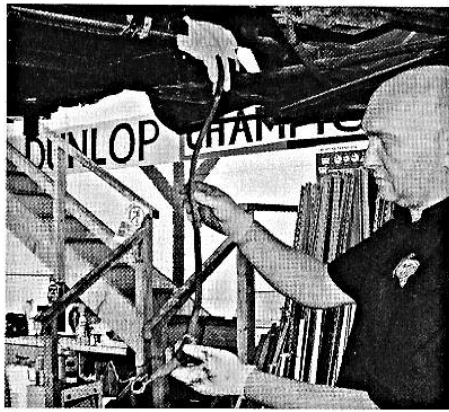
**3** ◀ The washer reservoir is hooked on to the front subframe, so Chris detached it but left it inside the front compartment. The battery is disconnected – the main power lead is pulled through to the underneath of the MG. On the TF, the live lead to the fusebox also needs to be detached.

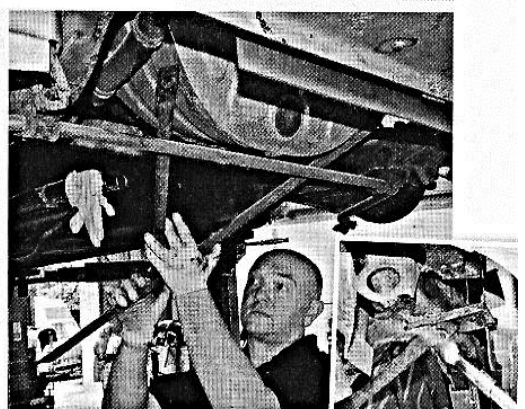
**6** ▶ On the TF, there's a brace bar fitted underneath the front subframe, which is secured to the rear most mounts and to the front corners of the front subframe with two more 13mm bolts. Chris wisely warmed these up before attempting to undo them. The brace bar was then removed.

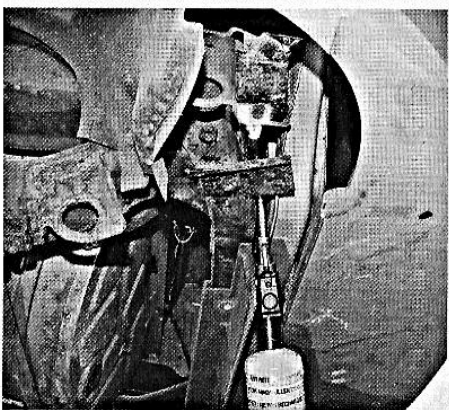
**7** ◀ At the front corners of the front subframe, there are two 10mm bolts for the front most mounts. These were also heated up before Chris attempted to undo them because they can easily shear. With all of the subframe's mounting bolts loosened, there were a few more items to detach before the subframe could be removed.

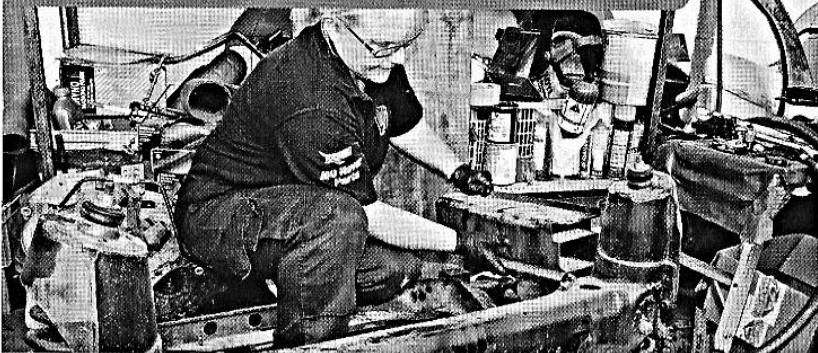
**1** Chris's wife, Dawn, volunteered to dismantle the TF's front subframe, so she started by spraying over all the fittings to be undone with plenty of penetrating fluid. She then moved on to removing the crash tubes, which are each secured with three 13mm bolts (sometimes 15mm instead).

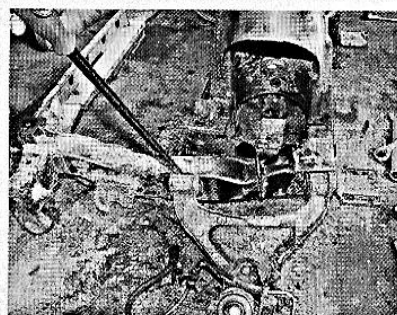
**5** The lower arm, hub and brakes remained and could be detached together, then dismantled later. Each lower arm is secured to the subframe with two 19mm bolts, which can be undone using a socket and extension bars. We had to lever the arms out of the subframe.

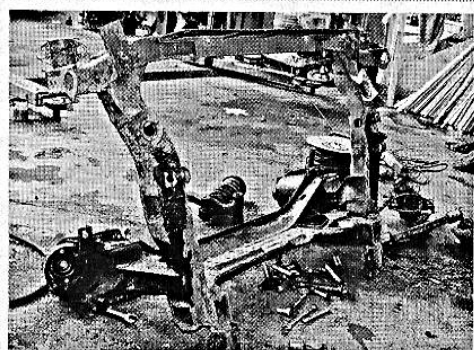
**7** ▶ With the exception of the subframe's mounts, which were seized and would need warming up or possibly cutting off, the front subframe was fully stripped and ready to be sent away for blasting and powder-coating.

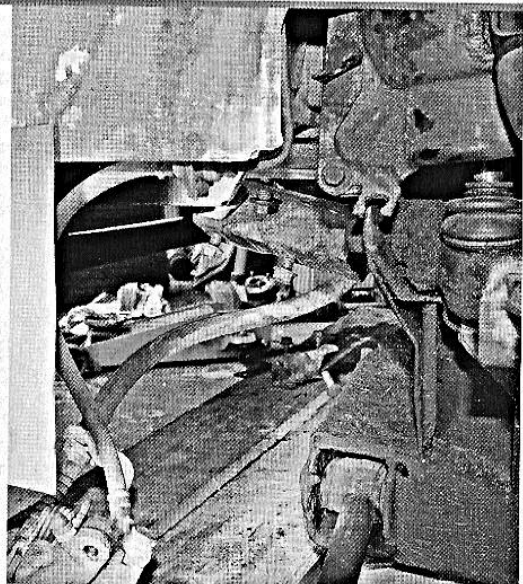
**2** The rearmost mounts were loosely fitted at first, ensuring the handbrake cable wasn't in the way. When Chris was satisfied the rear subframe was correctly positioned, he further tightened all the nuts and bolts for each of these mounts.

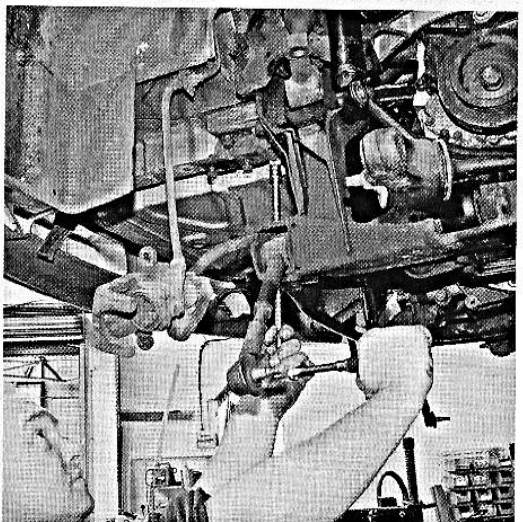
**3** Raising the whole vehicle on the two-post ramp, Chris secured the frontmost mounts to the underside of the bodywork.

**4** He then returned to the rearmost mounts and fully tightened all the nuts and bolts for each of them. All remaining parts were now refitted in reverse order of removal.
