# Is Your Old Rubber SAFE?

## Dodgy fuel lines are out there and you might have them on your MG

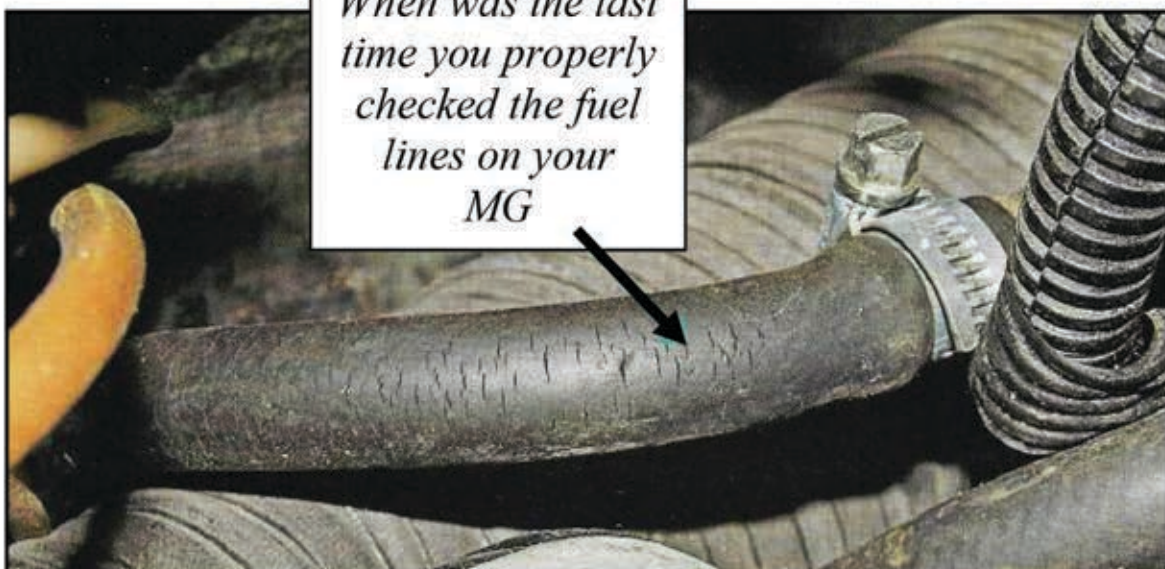
The photograph depicts a hose that was fitted 12 months and around 400 miles ago to a classic car.

We believe the cause of the decay in the image shown is fuel penetration into the inner layers of the hose, resulting in dryness and cracking in the outer layers. As the time of writing, we are unsure whether this is the result of a poor batch of hoses or fraudulent marking on substandard hoses. We'll keep you informed of developments.

Our advice to all classic car owners is to inspect your fuel hoses regularly and thoroughly - your car may have been fitted with fuel hose from a similar source, and it is vital to ensure the fuel system in your classic is sound. If you are looking to replace your hoses, only source from a reputable long-term suppliers and ensure you are getting genuine SAE J30R9 standard hoses with provenance.
